**ENVIRONMENTAL IMPACT ASSESSMENT REPORT
OF
THE PROPOSED CONTAINER TERMINAL MODERNISATION PROJECT
FOR
KENYA PORTS AUTHORITY**

**H.O. ADALA, LEAD EXPERT &
EARTH MATTERS CONSULTING
CANNON TOWERS, 3RD FLOOR
P.O. BOX 42269
TEL 222861
MOMBASA**

**KENYA PORTS AUTHORITY
P.O. BOX 95009
TEL. 2312211/2221211
MOMBASA**

MAY 2007

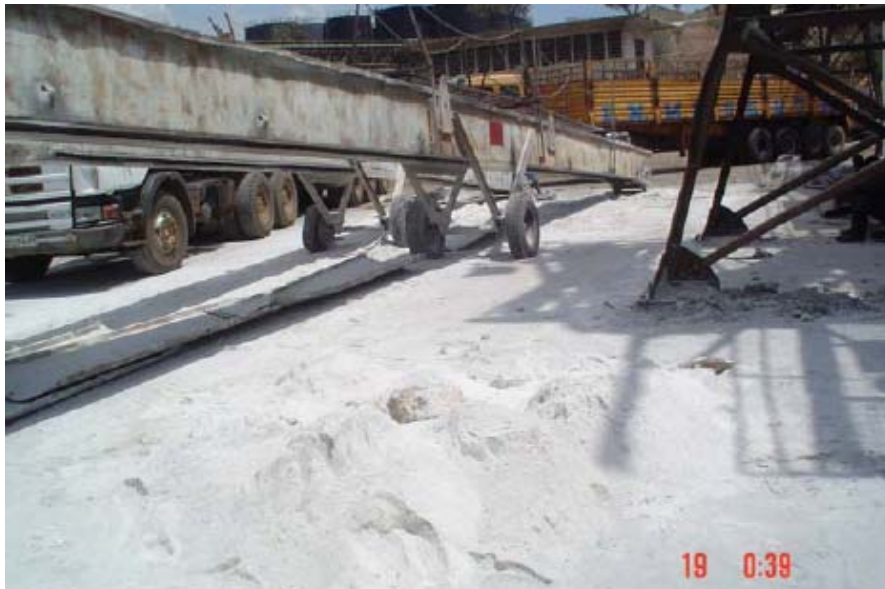
Figure 1.1: Spill of soda ash from Magadi Soda conveyor belt

Dry Cargo releases: There have been complaints of excessive dust releases during offloading of coal or clinker (for Bamburi Cement), soda ash (Magadi Soda, Fig 1.1) and occasionally during discharge of bulk grain (Grain Bulk Handlers Ltd). Some of the material finds its way into the ocean raising the Chemical Oxygen Demand (COD) to levels that may not be conducive for the survival of marine life.

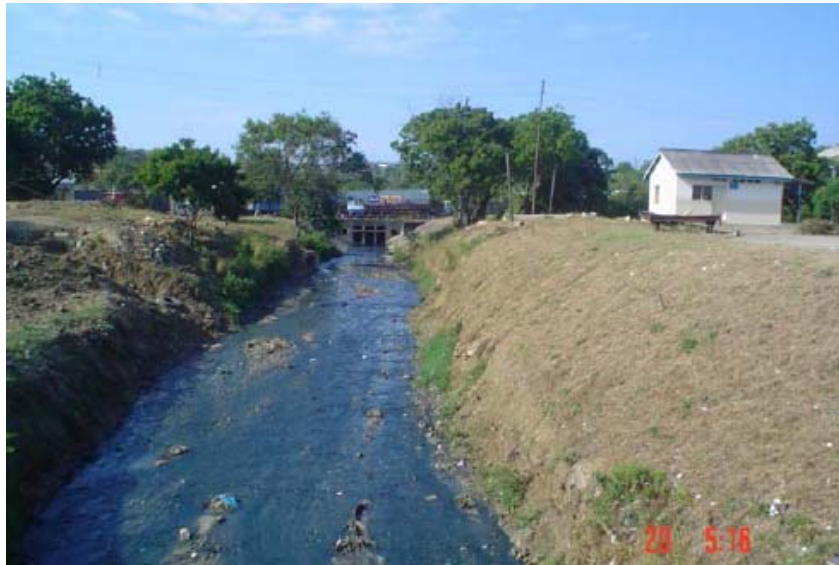
Figure 1.2: Untreated effluent from Municipal treatment plant discharges to sea

Water front industry discharges: Industries in the neighbourhood of the port discharge untreated sanitary and industrial wastes into the sea. There is also effluent from the Municipal sewage treatment plant (Fig 1.2) that is currently not functioning, consequently discharging raw sewage into the sea. Unfortunately this situation still prevails.

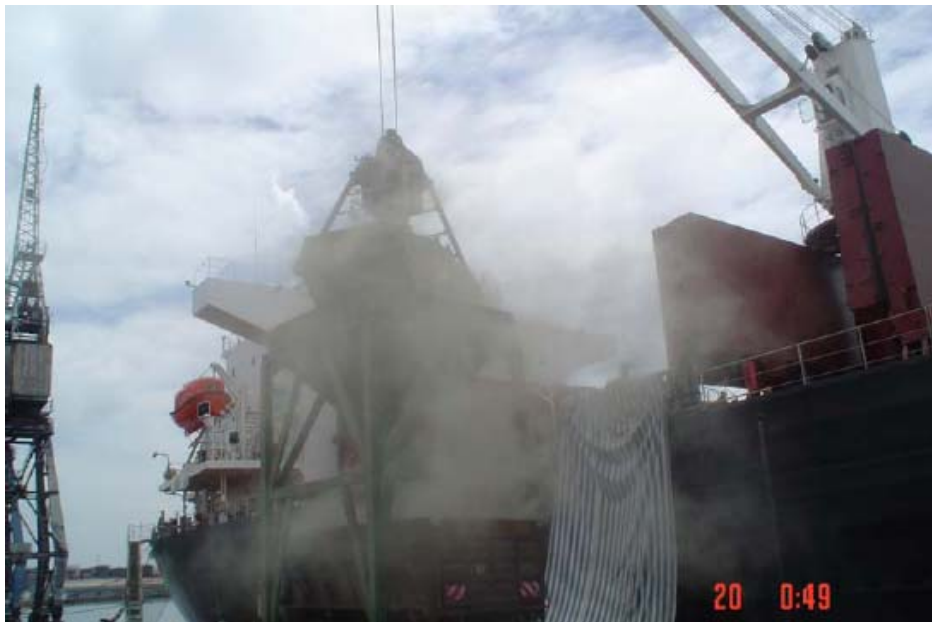
Figure 1.3: A grab discharging clinker into a truck

Dry Cargo Releases: As described above there is release of significant quantity of dust into the environment during offloading of dry cargo. Some of this is released as fine airborne dust, thereby lowering the ambient air quality standards. (See Fig 1.3)

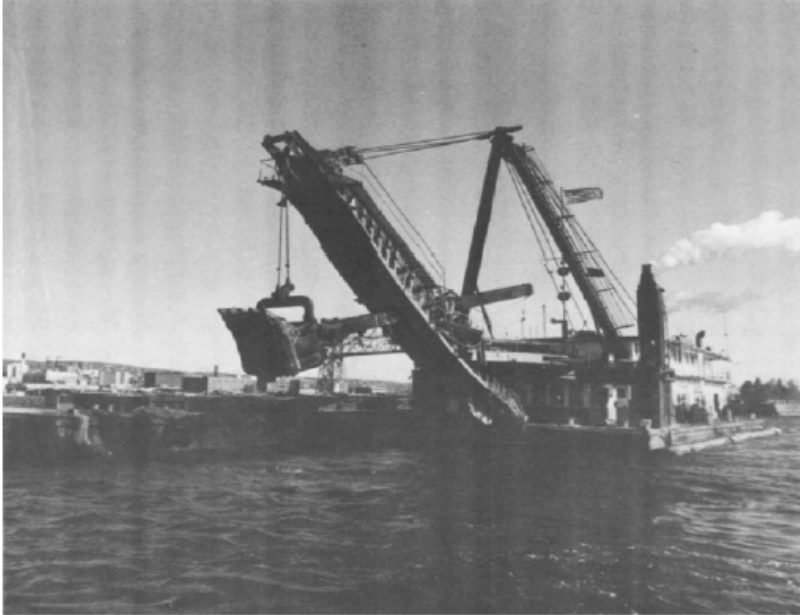
Figure.5.4: Dipper Dredge

dredges normally have a bucket capacity of 6 to 9 m³ and a working depth of up to 15 m. There is a great variability in production rates, but 30 to 60 cycles per hour is routinely achieved.

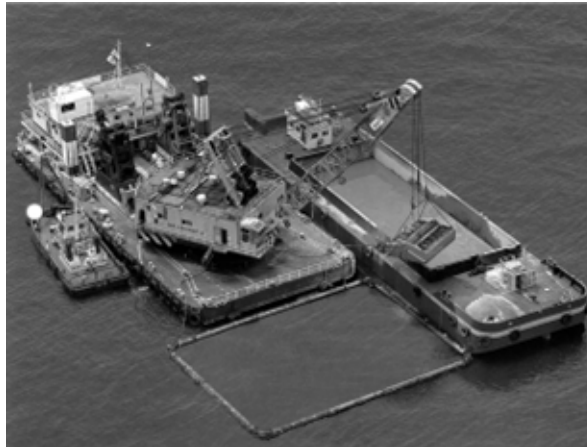
Fig 5.5: Grab Dredge (Contaminated Material Dredging)

Grab Dredgers are non-propelled barges equipped with a mechanical grab hanged by a crane arm. The grab is dropped into the water to dredge bed materials. The dredged materials are loaded on a transport barge staying next to the dredger. The transport barges with fully loaded are transported by a tugboat to designated dumping location to discharge the loaded materials. Empty barges go back to the dredging site to load next dredged materials. Dredging capacity of the dredgers is widely available depending on the volume and materials to be dredged.

In the event that the materials to be dredged have unacceptable levels of contaminants for open water disposal, the Grab Dredger with special special equipment (see Fig 5.5) will be most suitable.

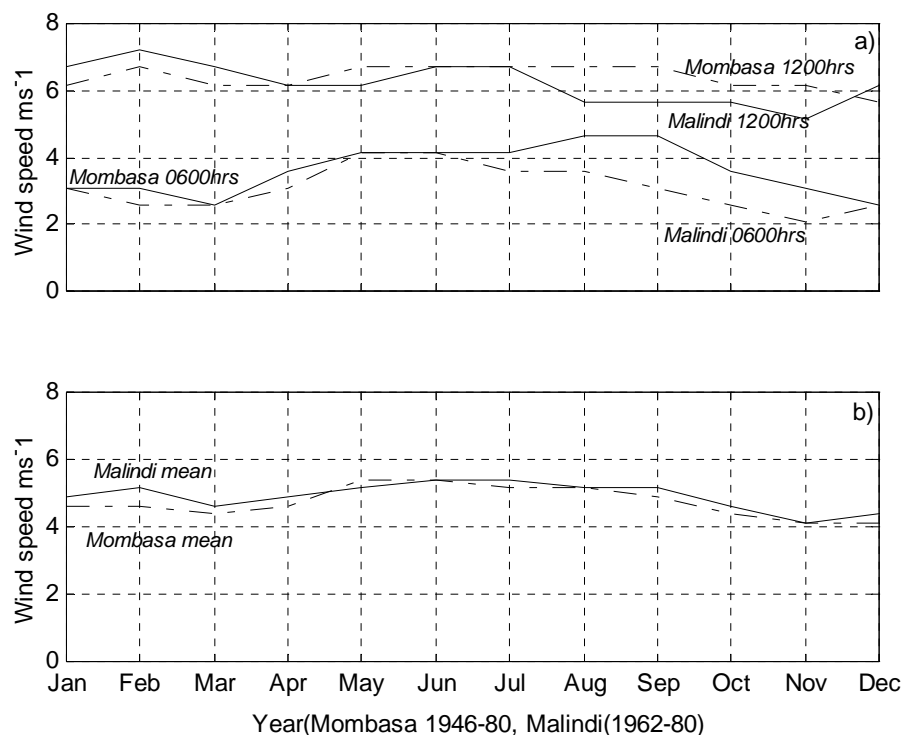
Figure. 6.3. Long-term monthly mean wind speed at (a) Port Reitz(Mombasa) and (b) Malindi Airports twice a day, at 06GMT and 12GMT (Nguli, 2006)

Wind direction in near the Kilindini entrance area (at KMFRI) varied between 145° and 200° , with a mean direction of 164° and a mean velocity of 6ms^{-1} , reaching maximum value of 9.5ms^{-1} (Nguli, 2006). The climatologically monthly mean wind speed at Port Reitz (at Moi International Airport) is shown together with those of from Malindi Airports for morning (0900hrs local time) and afternoon winds (1500hrs local time). Thus, as indicated there is a strong land sea breeze acting on top of the monsoon. The mean wind at the entrance is somewhat higher at the Port Reitz (Figure.6.3). Diurnal variations in direction and speed are strong. Stronger winds during daytime persisting up to late afternoon are caused by a sea breeze. The sea breeze implies that the seasonal variations in the daily mean wind speed are small.

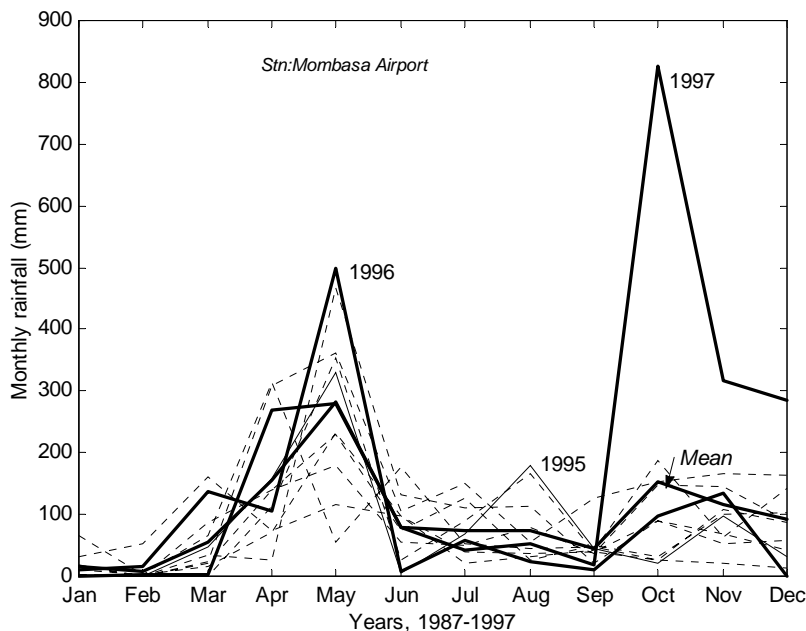
Figure.6.7. Monthly rainfall from (1987 to 1997), rainfall for 1995-1997 is emphasized to show above normal rainfall in the El-Nino year of 1997 (Nguli, 2006)

Monthly rainfall near the Port Reitz area (Moi Airport) for the years 1987-1997 is also shown (Figure.6.7). Rainfall from 1995-97 is highlighted to show the effects of excessive rainfall such as occurred during the El-Nino year of 1997. Considerable variations in the annual rainfall peaks values are observed, in the range from 150-850mm. The rainfall pattern is bimodal with the highest amount falling during the IMLR season and in IMSR season is evident. Rainfall varies considerably from one year to another. The year featured a total rainfall of 2175 mm, and coincided with the El-Nino year.

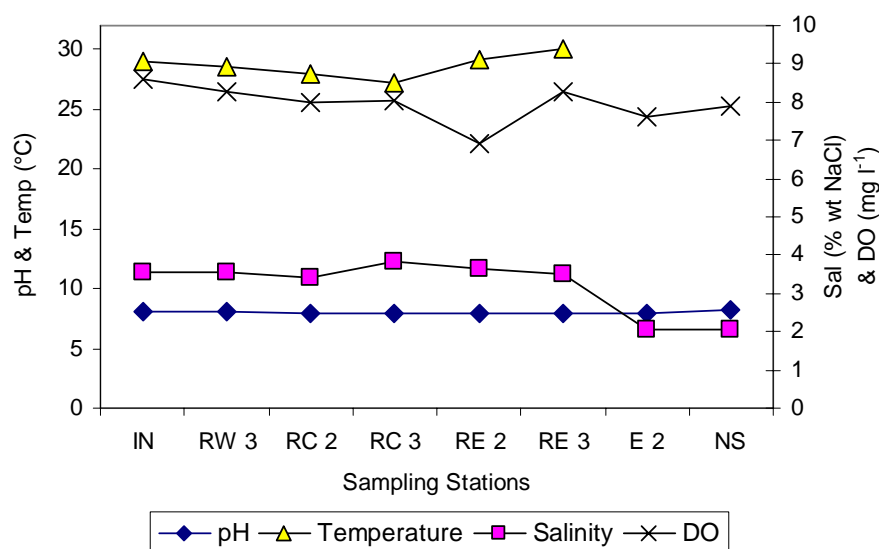
Figure 7.2: Variations of mean pH, temperature, salinity and DO in the water column

The observations of water column characteristics with respect to pH, temperature, salinity (as NaCl % wt) and DO in the study area are presented in Figure 7.2. The water pH varied within a narrow range 7.7 to 8.2 indicating an increase towards the open sea (station NS). Water temperature ranged from 27.1 to 32 °C and salinity from 32.1 to 35.1 psu with the higher salinities prevailing in the bottom layer. DO values ranged from 5 to 8.7 mg l⁻¹, with the lowest concentration recorded for a bottom sample from station RE 2. In general, the water column appeared well mixed at the time of sampling.

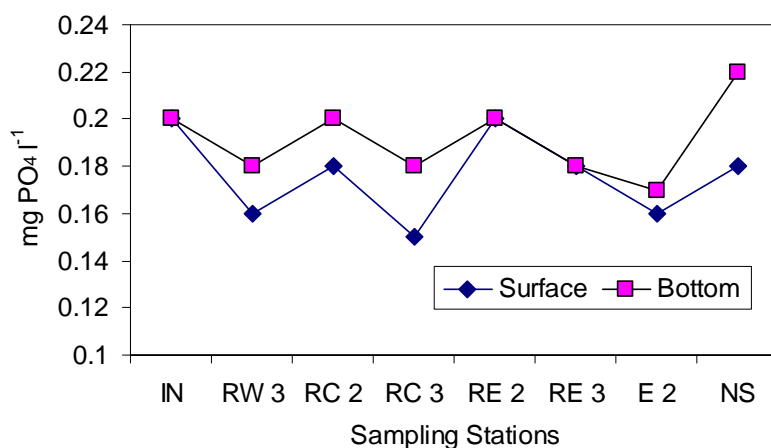
Figure 7.3: Phosphate concentrations in the water column

In the water column ammonia concentrations were below detection (< 0.03 mg N l⁻¹) which indicated efficient usage by primary producers. Concentrations of total phosphorus expressed as phosphate ranged from 0.15 to 0.20 mg l⁻¹, with generally higher levels found in the bottom water layer (Figure 7.3).

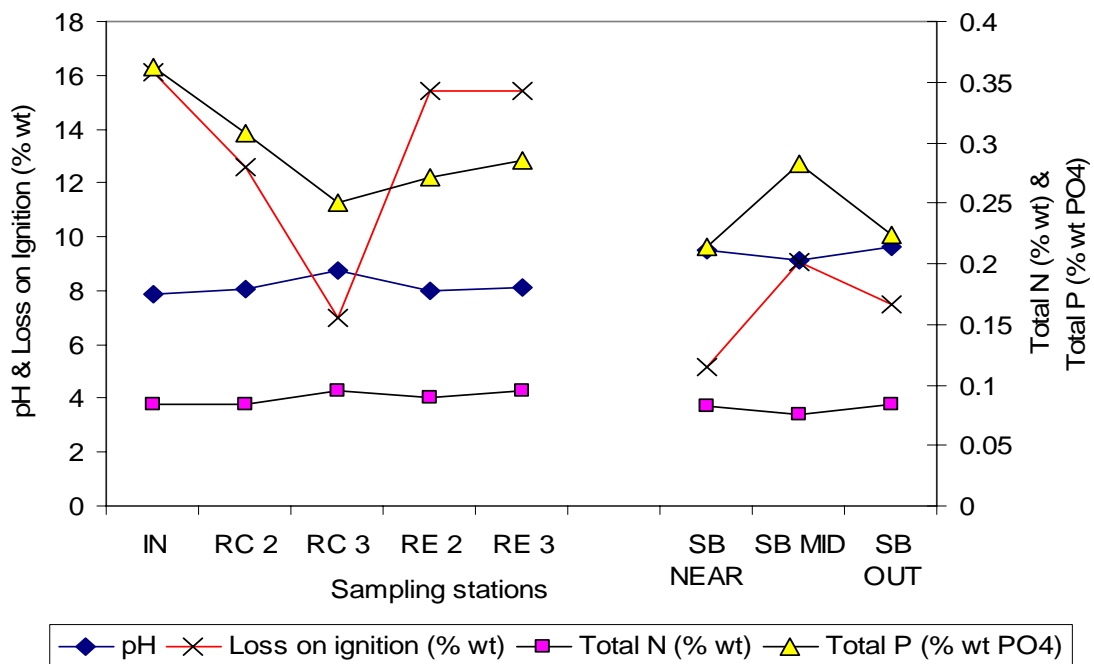
Figure 7.6: Physico-chemical properties associated with sediments. (SB = Shelly Beach).

variation of loss on ignition of the sediment samples, which signifies the association of phosphorus with organic carbon content of the sediment. The terrigenous sediments in the Port Reitz creek have higher organic carbon content, compared to Shelly Beach. Levels of TPH in the sediments were below detection ($<0.4 \text{ mg kg}^{-1}$).

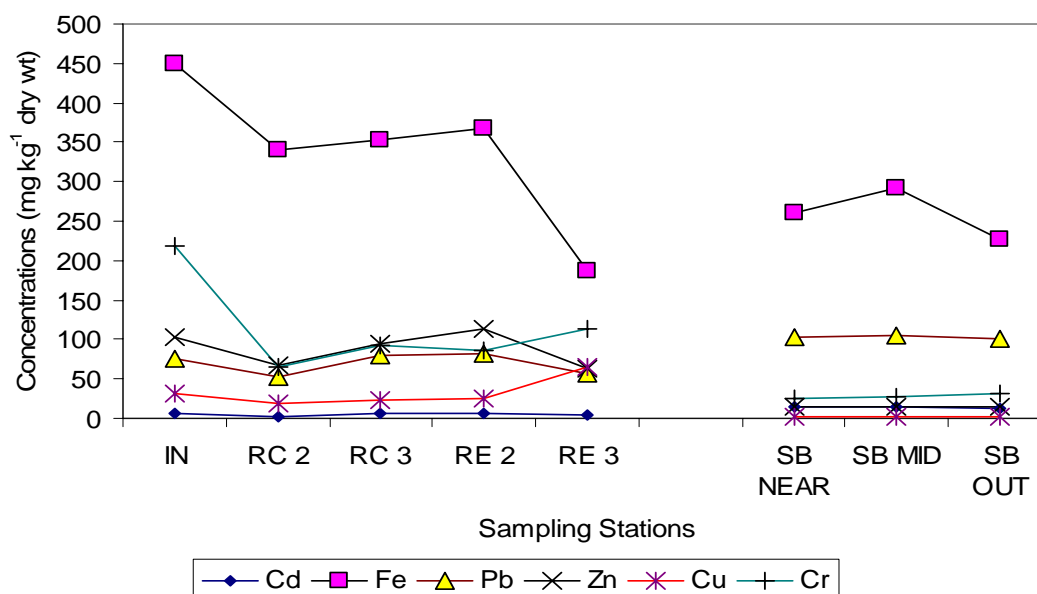
Figure 7.7: Variations of heavy metal concentrations in sediments

The results show generally decreasing trends in the sedimentary concentrations of Fe, Zn, Cu, and Cr moving from the Port Reitz creek to the Shelly Beach stations. The observed trends provide an indication of the association of the heavy metals with the organic carbon content of the sediments. The sediment size distribution in the creek with a relatively high proportion of silt provides higher surface area for sorption of the metal species.

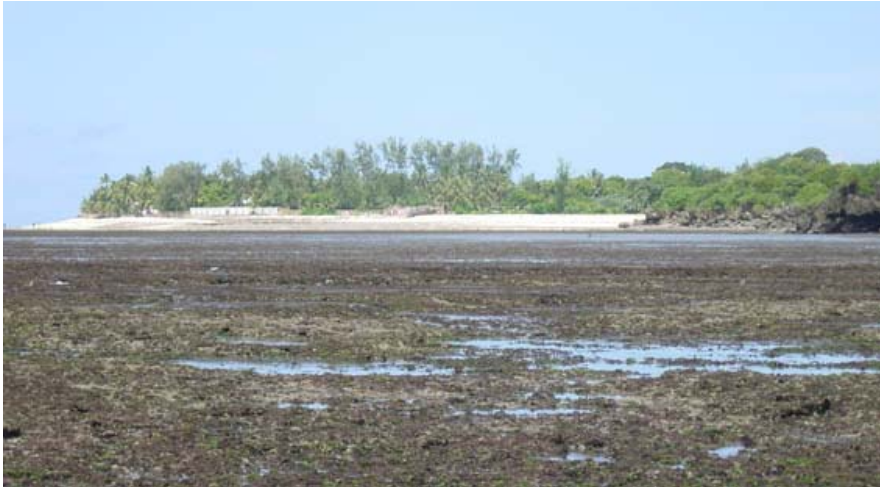
Figure 8.2: Shelly Beach at maximum spring low. The Intertidal reef flats as shown here correspond to areas marked green in Fig 2.2.

Figure 2.2 is marked in light green for shallow depths (less than 4 m datum depths), which also get exposed at maximum spring tides, and correspond to mudflats and mangroves (within the Port Reitz and Kilindini bay waters), and correspond to shallow lagoons, reef crests or reef flats and sandflats (within the Shelly Beach and Nyali Beach areas; Fig. 8.2).

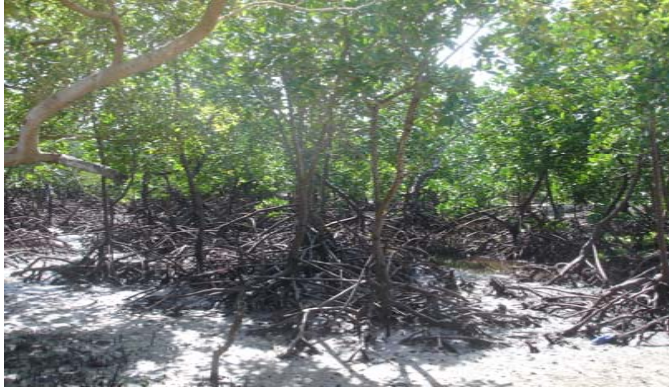
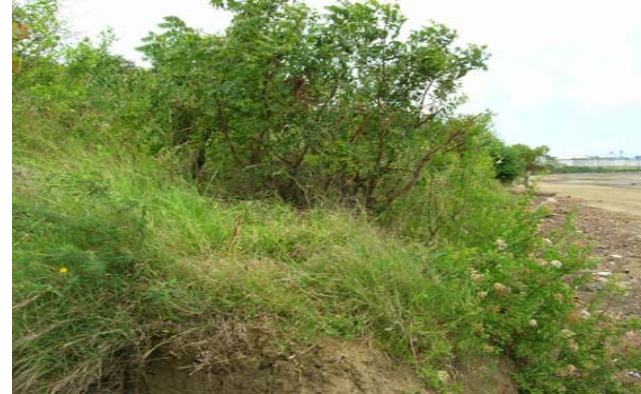
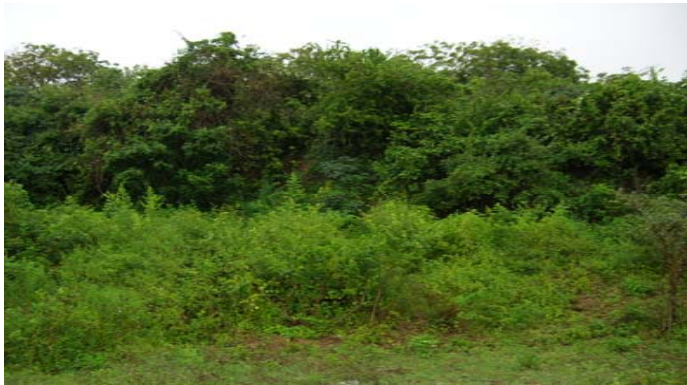
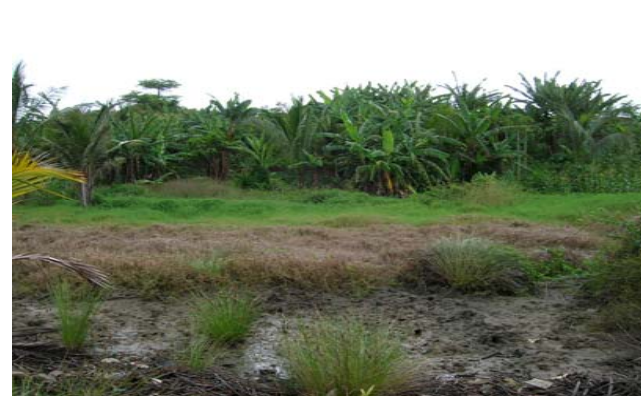
Rhizophora mangrove trees in an intertidal mudflat at Port Reitz creek

Mixed shrubs and grass vegetation on the banks of Port Reitz creek

Dry land tree and shrub thicket on the banks of Port Reitz creek

Man-made agricultural systems at Port Reitz creek

Figure 8.6: The main types of vegetation assemblage found along Port Reitz creek

Four types of natural vegetation assemblages and one for man-made vegetation (agricultural systems) were found in the Port Reitz creek, these are shown in Table 8.3 and Figure 8.6 below.

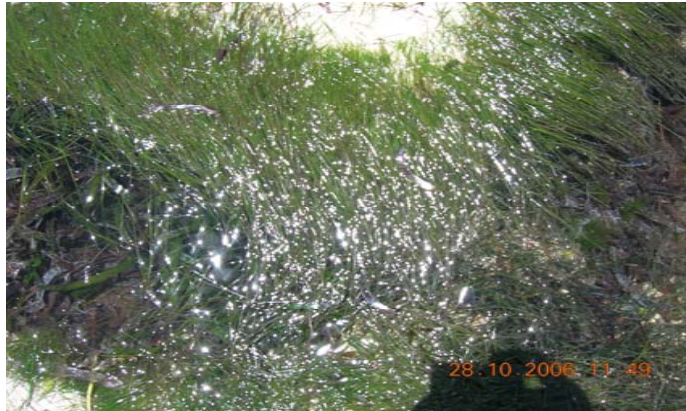
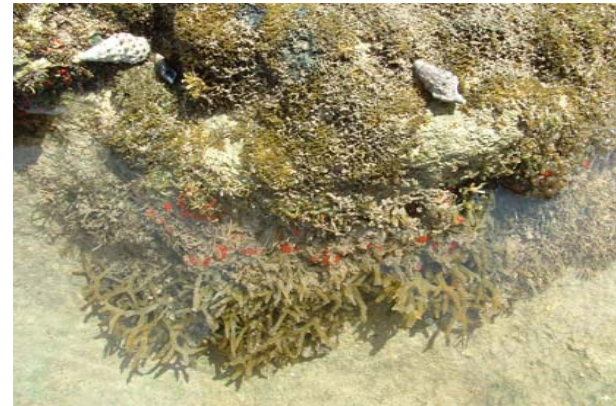
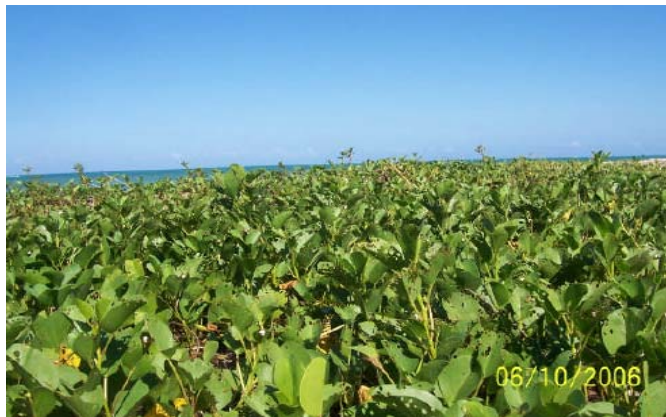
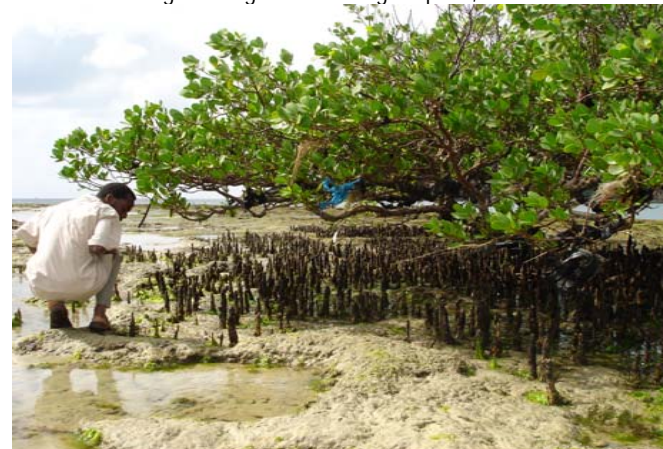
Sub-tidal sea grass beds (mixed species) at Shelly Beach

Sub-tidal seaweed vegetation (brown algae) at Shelly Beach

Beach rail-road vine vegetation at Shelly Beach

Sonneratia mangrove vegetation at English point, Mkonani

Figure 8.7: The main types of vegetation assemblage found around Shelly Beach and below right lone Sonneratia at Nyali's English point

Seven (7) species of true-mangrove plants and seven (7) typical species of mangrove – associates plants were encountered and are recorded (Table 8.4). There were no mangroves on the shelly beach area, though a relic of small mangrove was observed at the English point comprising mostly of *Sonneratia alba* (this survey Figure 8.7, Ruwa 1993). The community structure here was not investigated as they are far removed from the possible dredge/reclamation impact potential zones based on local knowledge of coastal flushing and hydrodynamics.

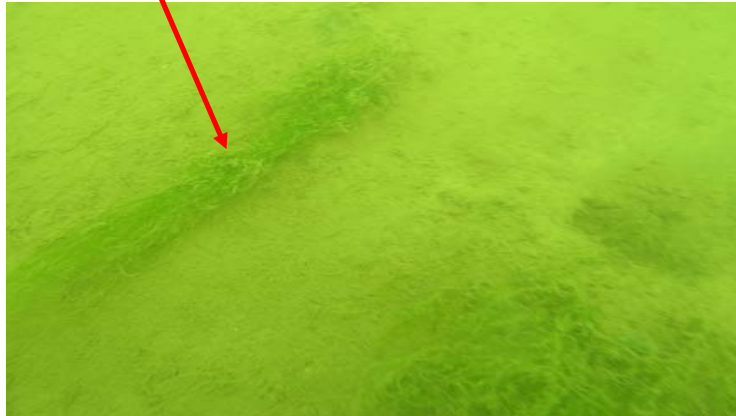
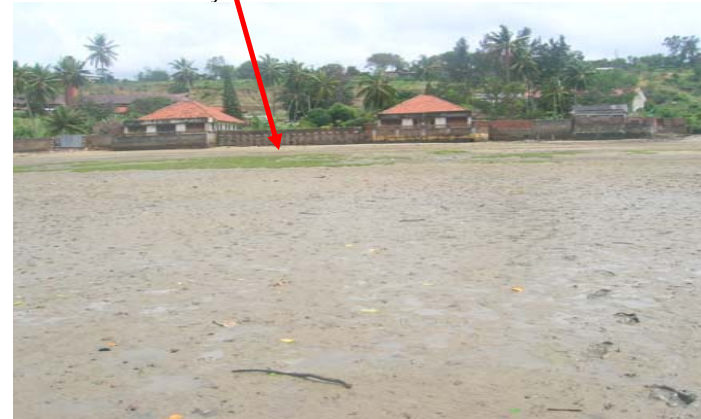
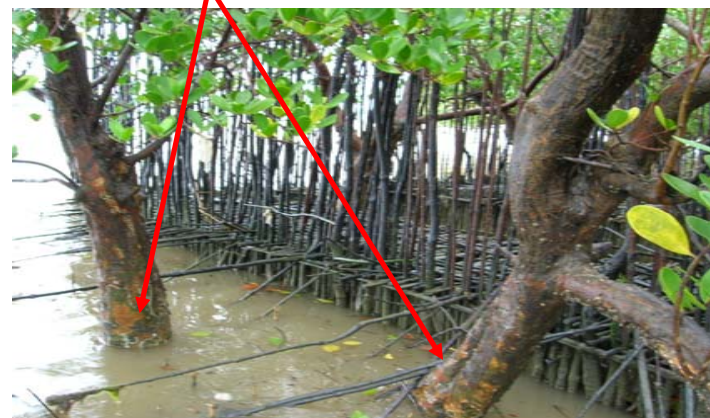
Enteromorpha sp underwater at bottom of areas to be reclaimed (Port Reitz) at high tide

Enteromorpha sp mat to the frontage of the Brick factory (Port Reitz) at low tide in front of brick factory

Encrusting seaweeds on mangrove roots/trunks factory (Port Reitz)

Figure 8.11: Types of seaweed community assemblages found in the Port Reitz creek & Shelly Beach

The seaweeds structure of Port Reitz comprised mostly blue-greens on silty sediments. Patches of *Enteromorpha crassa* on sediment surfaces, and scattered *Padina*, *Ulva* and floating *Sargassum* were commonly encountered. Some species were found epiphytic on mangrove roots (e.g., *Enteromorpha*, *Bostrychia* & *Murrayella* spp. on *Avicennia*) (Figure 8.11).

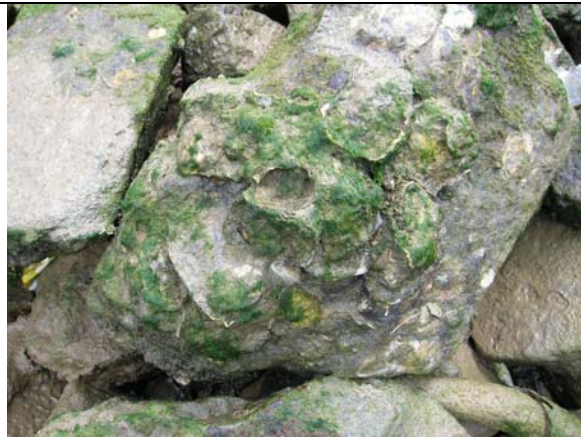
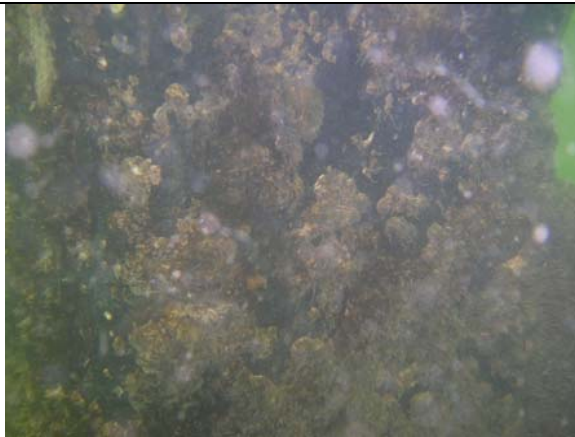
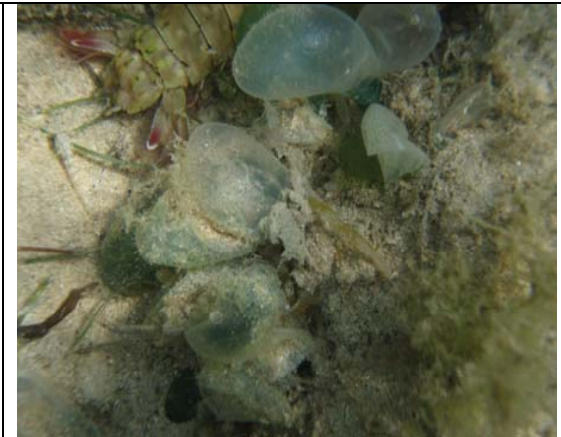
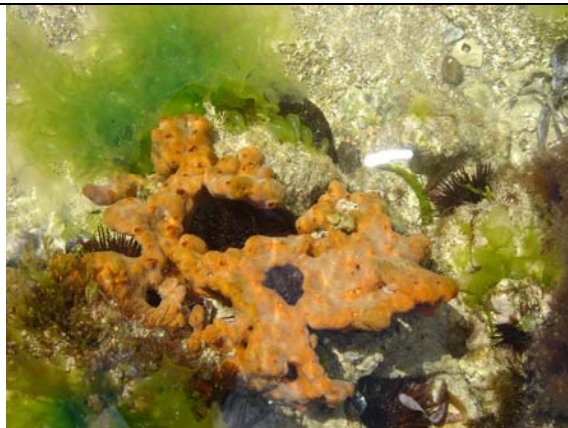
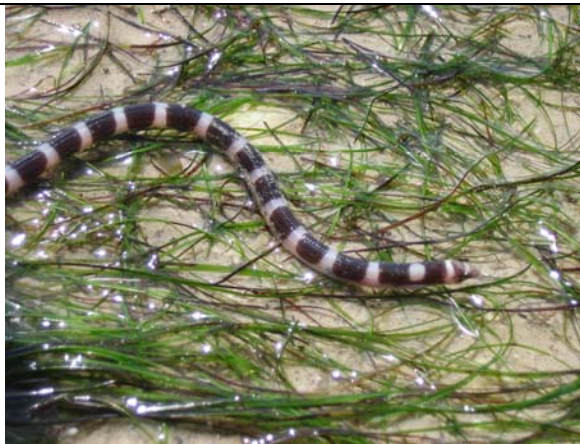
Oysters on concrete wall around Beth-19

Pits & depressions with benthos on seafloor of Port Reitz

Mixed benthos & slow sessiles on seafloor of Shelly beach

Sponges, seaweeds and benthic fauna at Shelly beach

Eel on seagrass (Halodule) at Shelly beach

These comprised the wide reef flats in front of the high-raised cliffs. Rocks in the upper part of intertidal zone had a sparse biological activity, with mostly unicellular algae and fleshy alga, and a fauna of chitons and limpets and some amphibian crustaceans. Some sub tidal rocks have developed a richer flora and fauna resembling the conditions found on coral reefs. In the survey areas, we did not get good coral life forms. Hard and soft corals were found in discrete patches, surrounded by algae and seagrass beds. Benthic invertebrates were seen varying in cover from zero to about 30% (mostly for sea urchin colonies) and some of these are presented in Fig. 8.18.

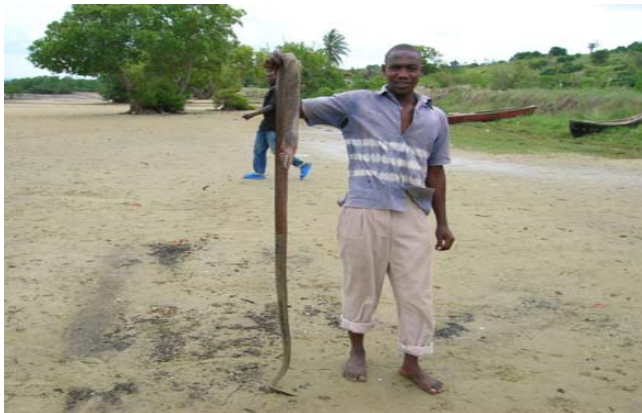
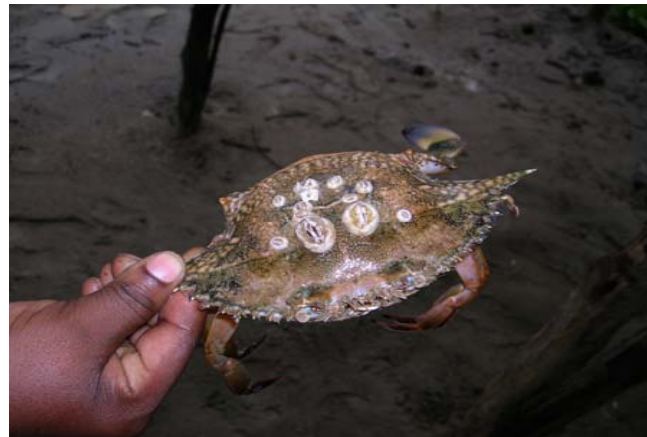
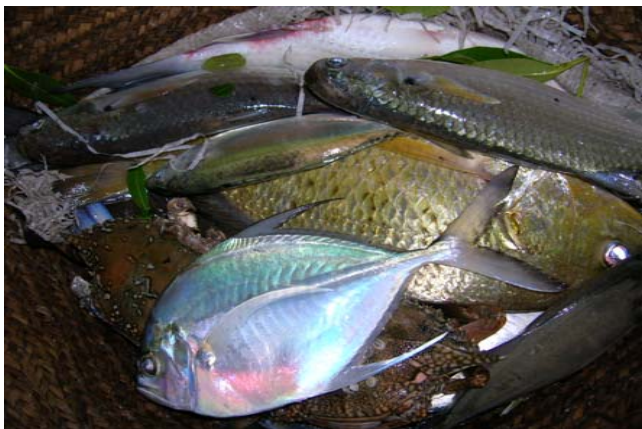
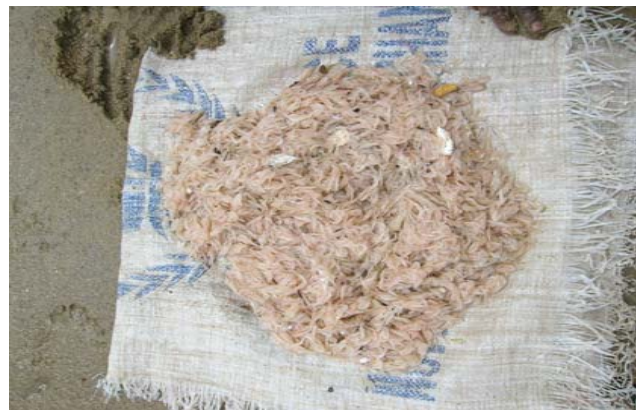
Estuarine edible eel (*Muraenesocidae*) captured at P. Reitz

Edible crabs (*Portunus* spp) captured at P. Reitz

Mixed species (*Carangidae*, *Pomadysidae*, *Mugilidae*, *Scombridae*) at P. Reitz

Juvenile of *Penaeus indicus* shrimp (harvested at Port Reitz)

Figure 8.24: some of the primary resources exploited from the Port Reitz creek showing a rich fisheries biodiversity during a commissioned survey by fishermen

The Port Reitz creek which surrounds the Island town of Mombasa in the southwest has a total coastline area estimated at 2250 ha (Fulanda 2002). Suitable mariculture sites have been estimated to cover over 60% in the swamp areas in the mangroves (Fulanda 2002). Two community crab farming projects exist in Tsunza and Kwa Skembo area. Fresh water fish ponds rearing Tilapia and catfish also exists along the creek which may be affected if any construction is extended on the mainland. Therefore there is a high aquaculture potential along this Creek and any development should the lost aquaculture opportunity an alternative to capture fisheries and hence enhancement of food security in this area. There are three access routes to the three landings sites which should be considered if any land development is to take place. Some of the actual species sightings were recorded during the reconnaissance surveys (Figure 8.24).

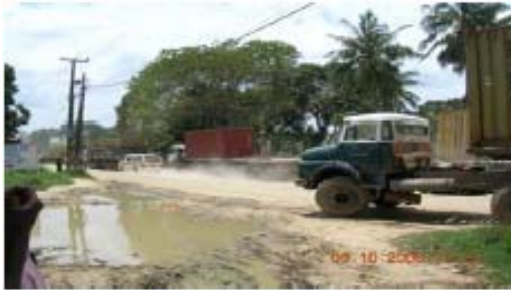
Plate 5: A *matatu* van maneuvers on the dilapidated Portreitz road.

The Portreitz-Kipevu-Kwahola area is served by van (*matatu*) services as the main mode of transport. This public transport however suffers from the poor condition of the road between Portreitz and Kwahola (**see plates 5 and 6**).

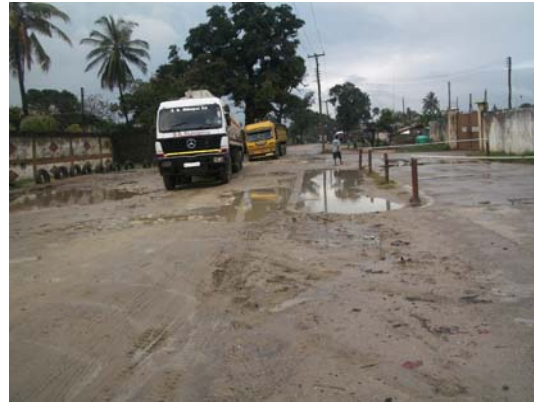
Plate 6: The Portreitz road in its current state.

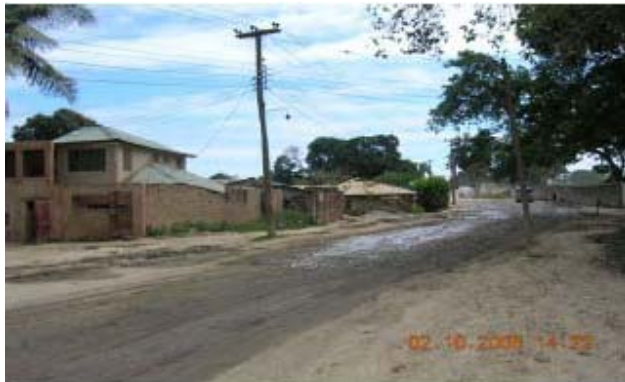
Plate 9: Electricity line running parallel to the dilapidated Portreitz road

The entire Portreitz-Kipevu-Kwahola area is served with electricity with the main electricity line running parallel to the Portreitz-Kwahola road (**see plate 9**).

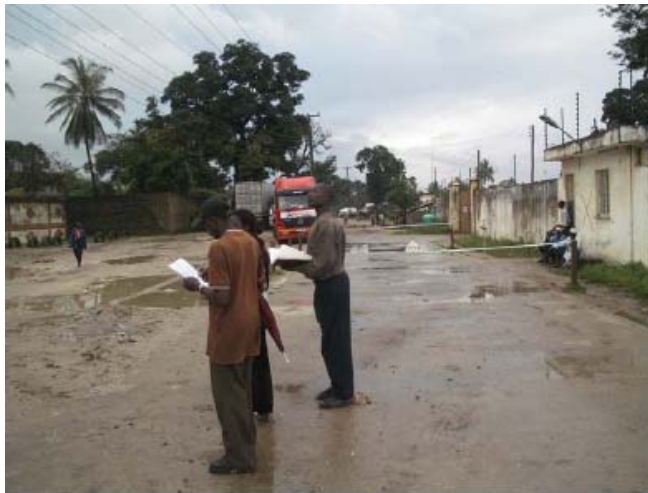
Figure 10.1: Traffic volume survey along Port Reitz road. Note the dilapidated state of the road

The project will result in more vehicular traffic, hence the increases and their impacts had to be evaluated. Land traffic survey was done from 20th to 29th September 2006 along the three roads likely to be impacted on by the project namely Port Reitz road, Airport road and Magongo road. As part of the assessment to the alternative proposal by Pacific Consultants International traffic survey was also done on Kenyatta Avenue at Kibarani on 31st October and 1st and 2nd November 2006. The traffic observation points are indicated in Fig. 6.1.

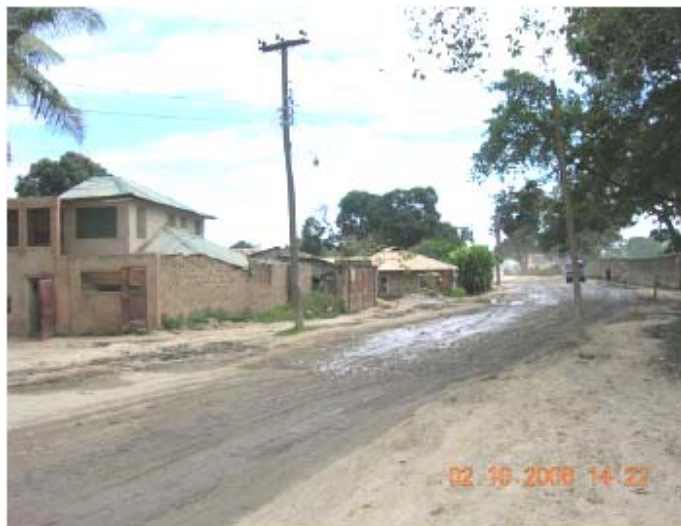
- Electricity line that runs parallel to the Port Reitz road may have to be relocated to create room for the proposed expansion of the current Port Reitz road.

Power line along the entire road will have to be relocated

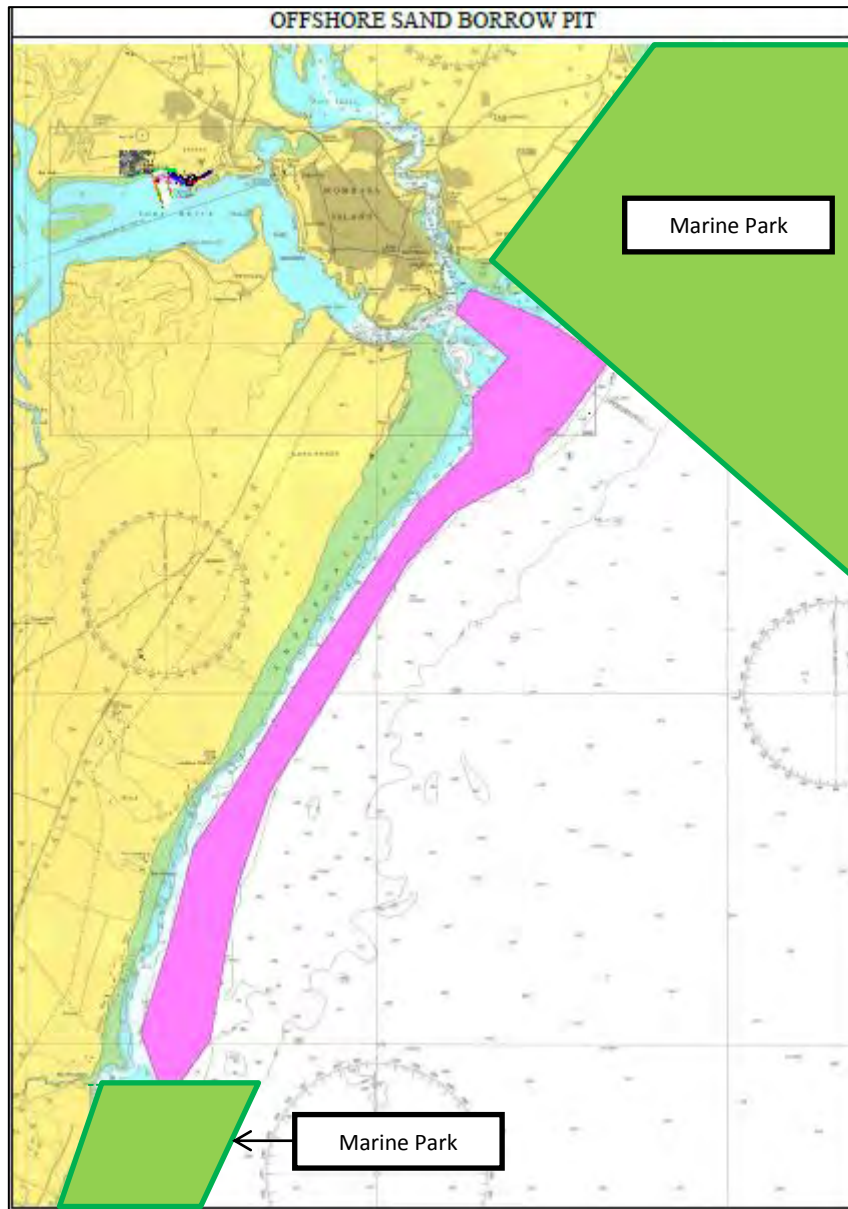
Figure 1.2: Revised Sand Harvesting Location (Sand Borrow Pit)

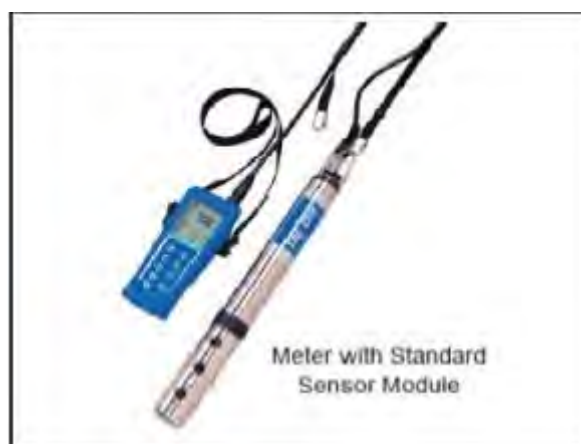
Figure 5.1: Water Quality meter and Sensor Module (WQC 24)

A relationship between turbidity and TSS was determined from the water samples collected. The Model WQC-24 (See Attachment 2) is the latest development in DKK TOA's range of multi-parameter water quality meters. Available parameters include: pH, DO, Conductivity, Salt, Total Dissolved Solids, Temperature and Turbidity.

Water quality monitoring was undertaken at the prescribed monitoring points at the project site using a water quality meter model **WQC-24**. Baseline monitoring was conducted between the 18th day of July 2012 and 16th day of August 2012. Direct reading for turbidity was done using the turbidity meter for points T1 to T7 for 14 days while samples were collected from points T2, T4 and T7 for 30 days. Sampling was done simultaneously with direct reading of other required parameters at 50cm, 3m and 6m. Samples were then taken to the NEMA approved laboratory for testing of TSS.

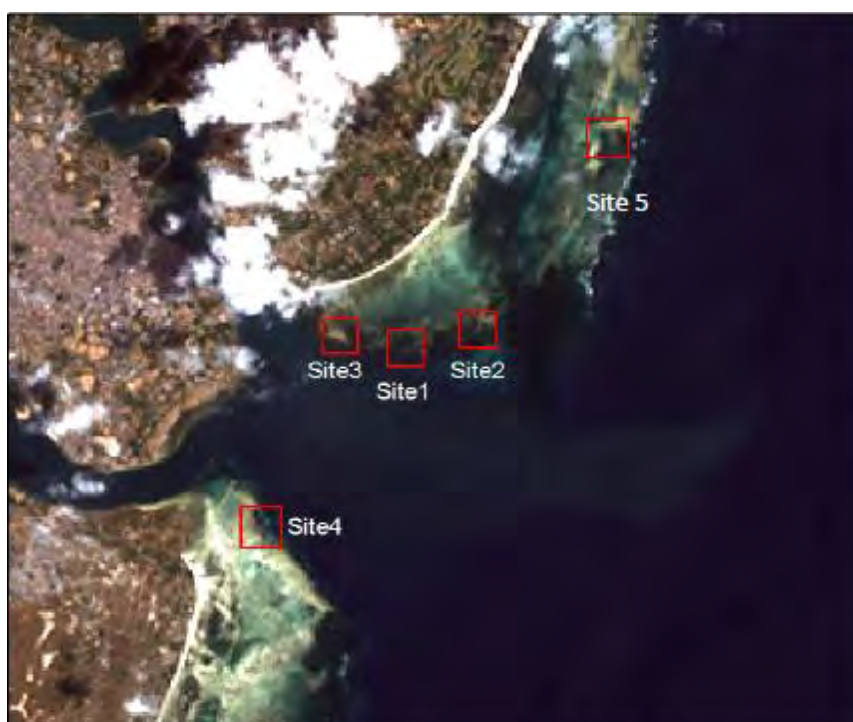
Figure 5.7: Flora & Fauna Monitoring Locations

A survey on marine vegetation and fauna is carried out at 5 monitoring points (see figure 4.1 and Table 4.2) of ecological interest to monitor the effects of the project on marine activities. The frequency of the monitoring is twice a year for the duration of construction works. The sampling is carries out monitoring using Underwater Visual Census (UVC).

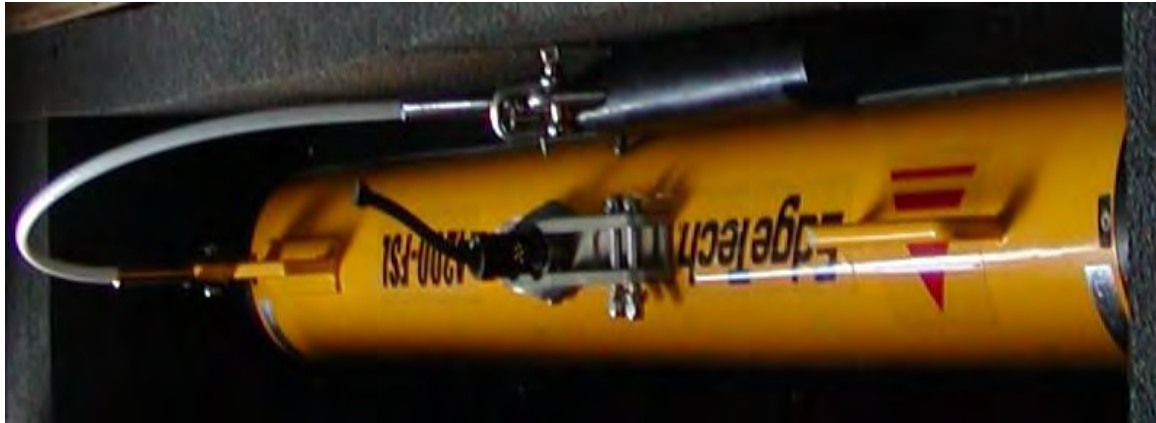
Figure 6.2: Edgetech 701 DL 'Fish' for Side Scan Sonar

An *Edgetech 701 DL* (the “fish”) system with a swath was used for the side scan sonar. A 100m range of track lines were used with 100% overlap with adjacent run lines.

The fish system was used to capture the surface features of the seabed and was generally run at a range of 15m to maximize on the depiction on any seabed sand ripples. In coral areas, it was run higher at 20m off seabed.

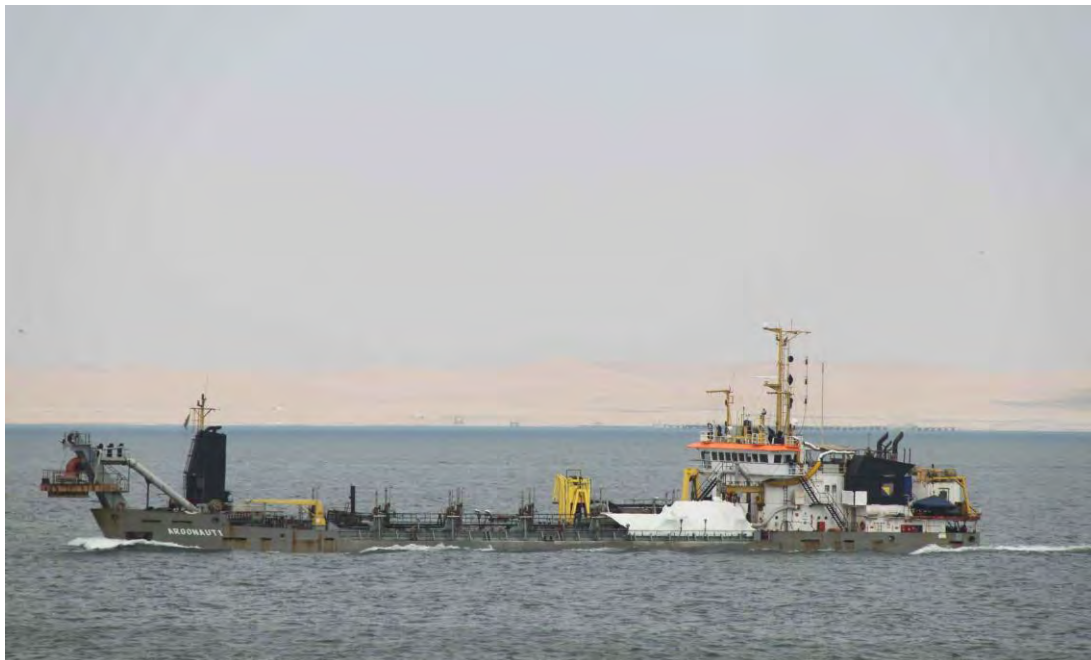
Figure 7.4: Pictorial Illustration of Trailer Suction Hopper Dredger (TSHD)
Source: MPDP
