**PREPARATORY SURVEY FOR FLOOD RISK
MANAGEMENT PROJECT**

CAGAYAN DE ORO RIVER (FRIMP-CDOR)

ENVIRONMENTAL IMPACT STATEMENT

NOVEMBER 2013

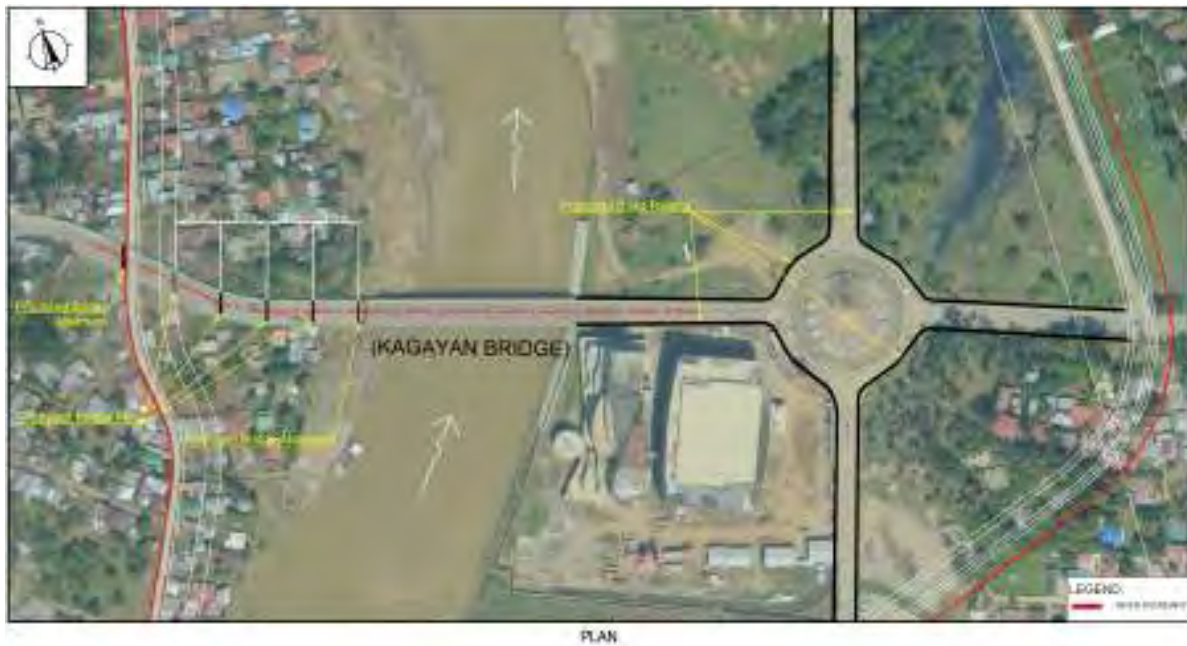
- Left Abutment and Approach:** The existing abutment and approach will be demolished and be replaced by bridge structures such as piers to increase river flow area and construction of new dike
- Right Approach Road:** The approach will be raised up to design bank level to maintain public transportation, access and evacuation during flood.

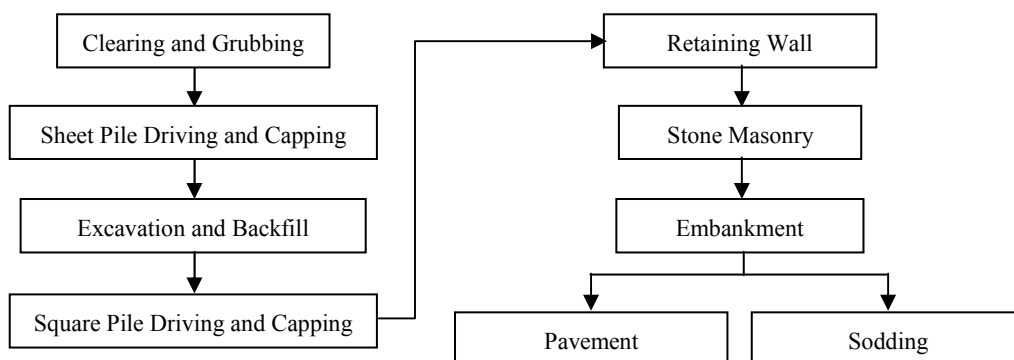
Figure 2.4.2 Construction Flow of Flood Wall

Flood wall consists of pile foundation, concrete retaining wall, stone masonry, embankment road pavement, sodding and pedestrian. Flow of construction is shown in the figure below.

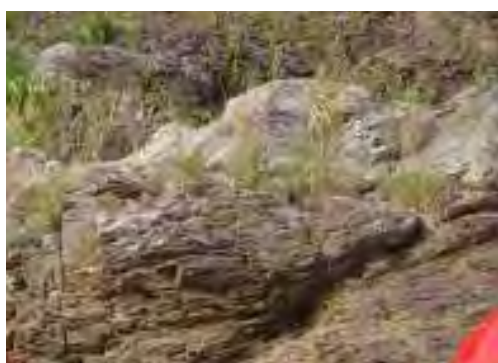
Pelitic schist, which is accompanied with dike of granodiorite, is observed at the Cepalco hydraulic power plant.

**Metamorphic rock (near 17km)
Fold Axis of the East-West
Direction**

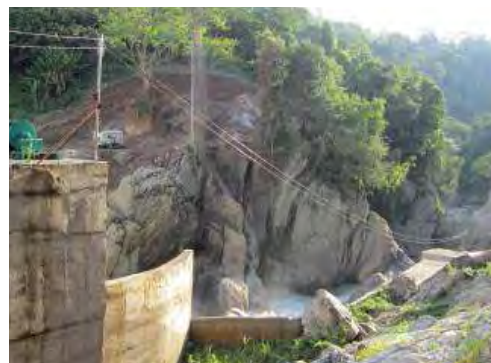
Figure 3.1.2 Metamorphic rock and Pelitic schist near CEPALCO Power Plant

**Pelitic schist
Cepalco hydraulic power plant**

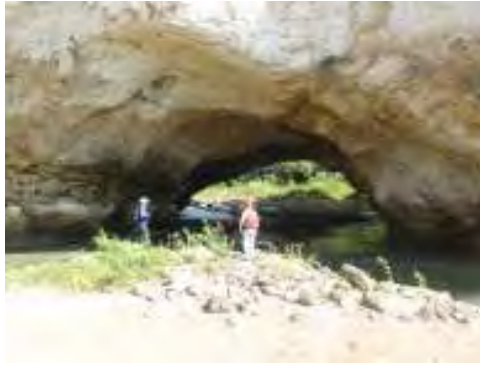
Sedimentary rocks, which are partially formed by the development of bedding stratification, form the steep cliff or the limestone cave.

Tumalaong Cave
Limestone
(Confluence of Tumalaong : near 22.5km)

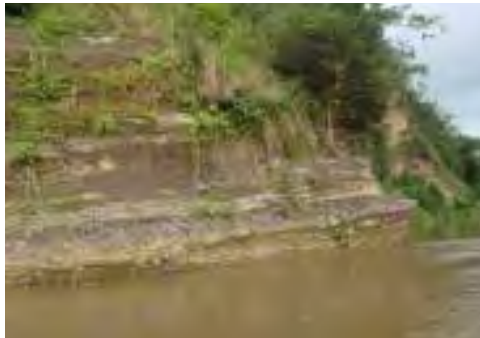
Sedimentary rocks (near 13km)
Alternation(Tertiary)
(Conglomerate/Sandstone/Siltstone)
The steep cliff is about 120m high.

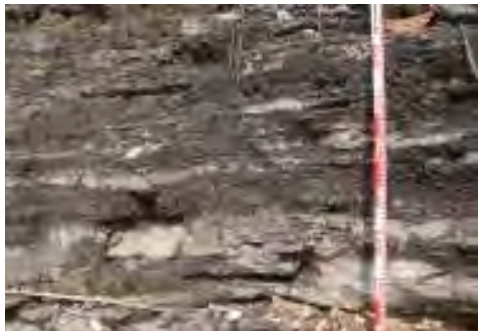
Siliceous Sandstone (near airport)
(Alternate of Limestone and Sandstone)
Slope failures are observed in several places;
Weak resistance to erosion

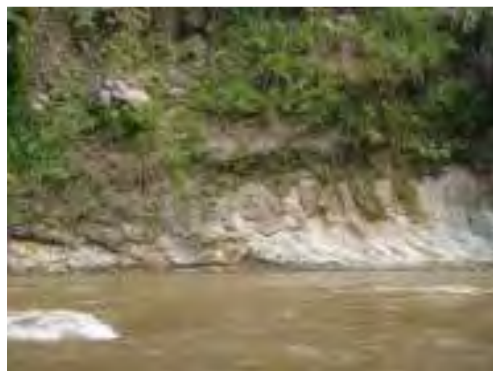
**Tuff (near 39km)
(Weak Welding: Columnar Joint
partially)**

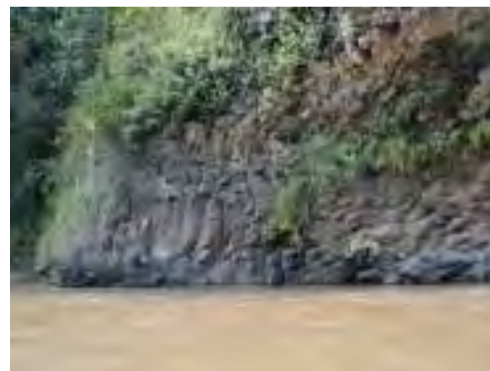
**Welded Tuff (near 38km)
Developed Columnar Joint**

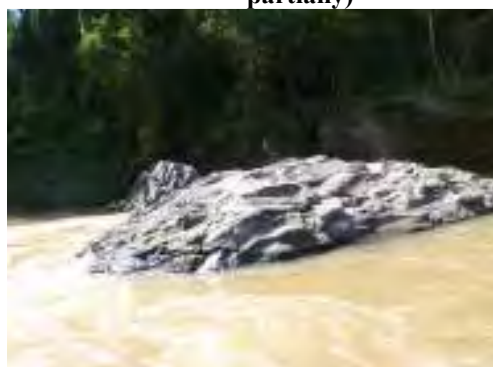
**River condition (near 24km)
Bounding Stone of Welded tuff
(Shark Deep)**

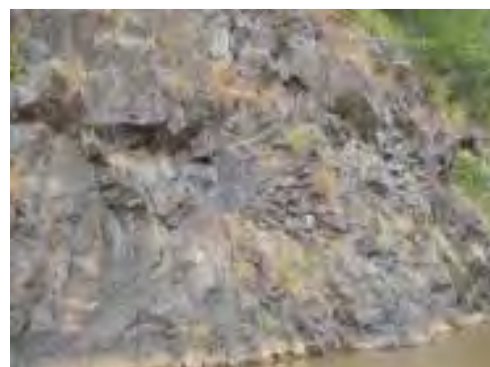
**Basaltic Andesite (near 14km)
Bedthickness: about 40m high
Radial Joint by rapid cooling**

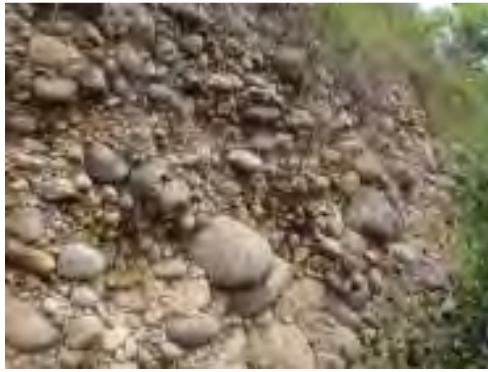
Gravel Layer near the Higher Terrace
Diameter : 5-35cm
Matrix : Little

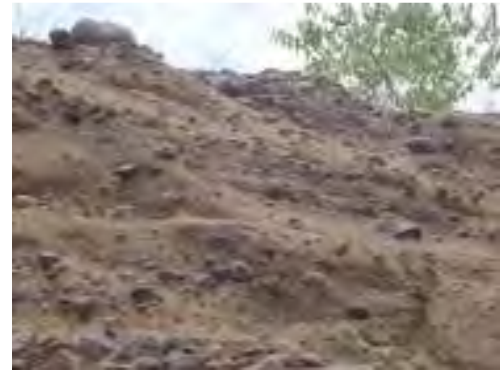
Gravel Layer of the middle terrace
Diameter : 5-15cm
Matrix : Volcanic Ash and Sandy Soil
Locally Cross Lamina

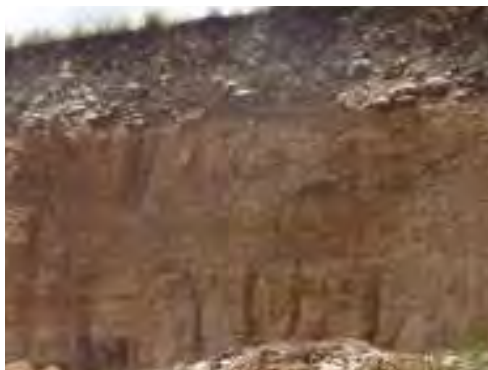
This shallow water deposit which consists of volcanic silt and cohesive soil with sand and gravel is formed horizontal layer. This layer is covered with Cagayan Gravel Layer.

The Higher Terrace located at the northern part of CDO Airport
Upper Layer: Cagayan Gravel layer
Lower layer: Shallow water Deposit

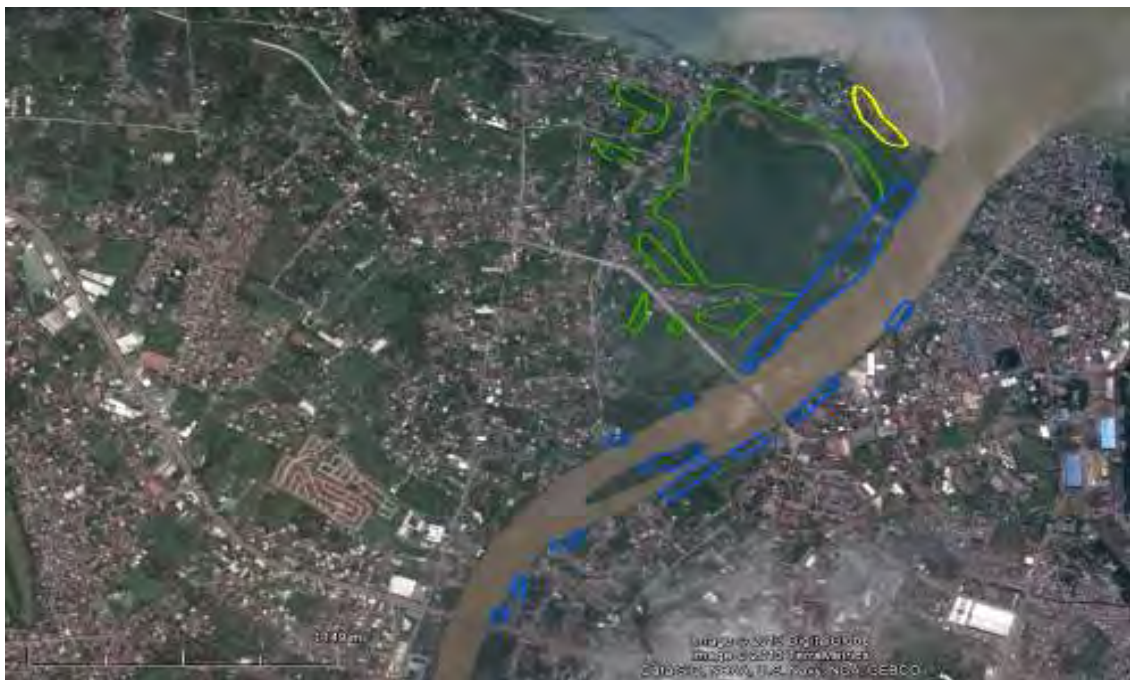
Figure 6.2.4 Preliminary Base Map Used During the Survey

A map below (**Figure 6.2.4**) was created based on the map (**Figure 6.2.5**) of the preliminary survey results of mangrove conducted by JICA Survey Team in February, 2013, indicating the location of the three mangrove forests in the Survey area. The map was used to guide for delineating the mangrove forests in the required survey area.

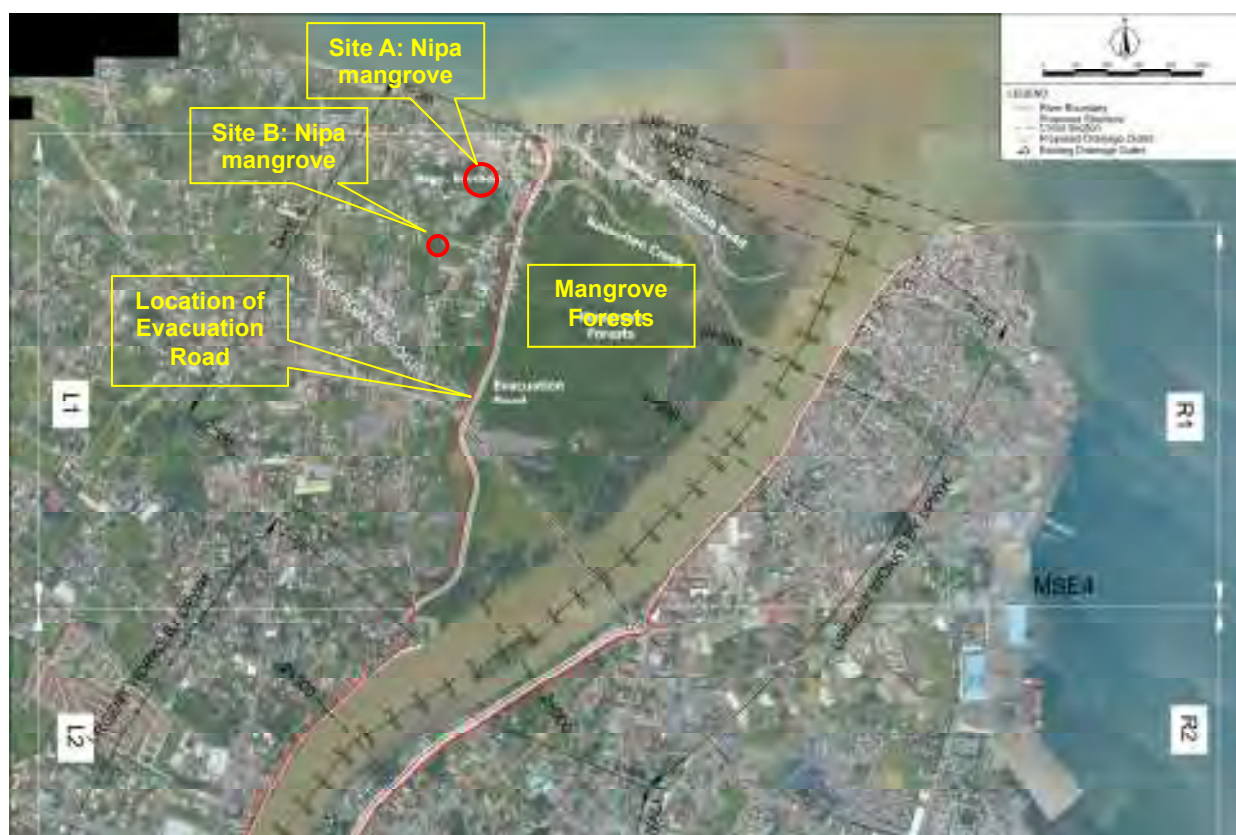
Figure 6.2.7 Potential Impact Area of Mangrove Forests

Figure 6.2.7 shows the location of dike (evacuation road) and floodwall construction of the Project in the downstream area of CDO River. Most of the mangrove forests are located near side to the river than the location of dike (evacuation road) in the area of Brgy. Bonbon. However there is the area of mangrove forests at west (further side) of the dike construction in Bonbon (Site A and B: Nipa mangrove on **Figure 6.2.7**).

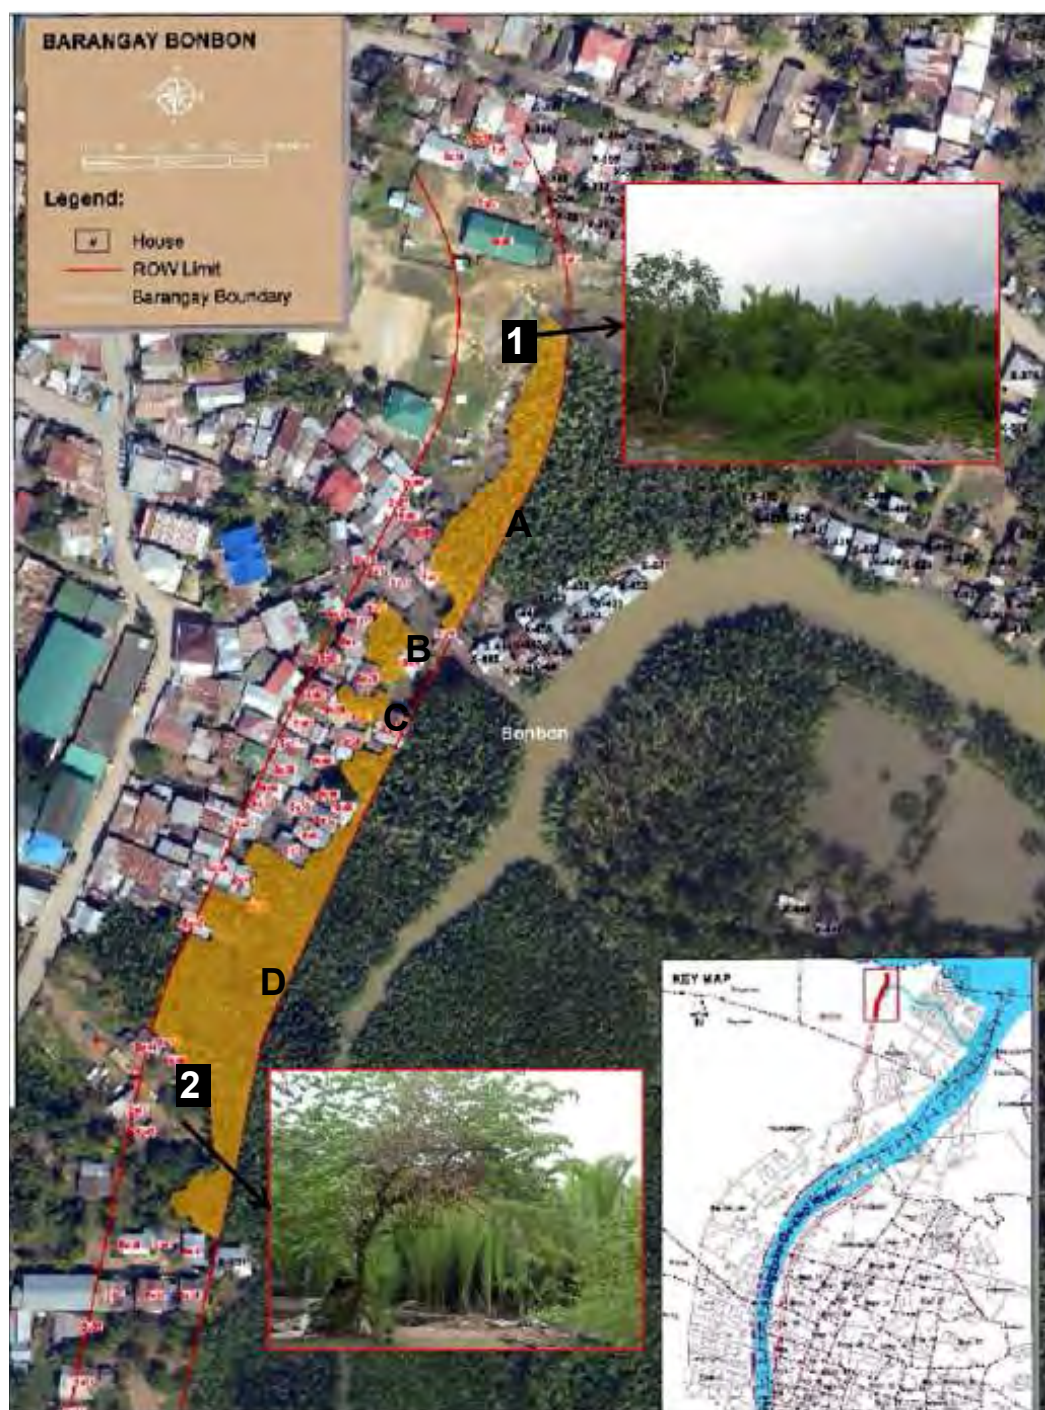
Figure 6.2.8 Mangrove forest to be affected by construction of project facility (evacuation road) near Barangay Bonbon (1 of 4 figures)

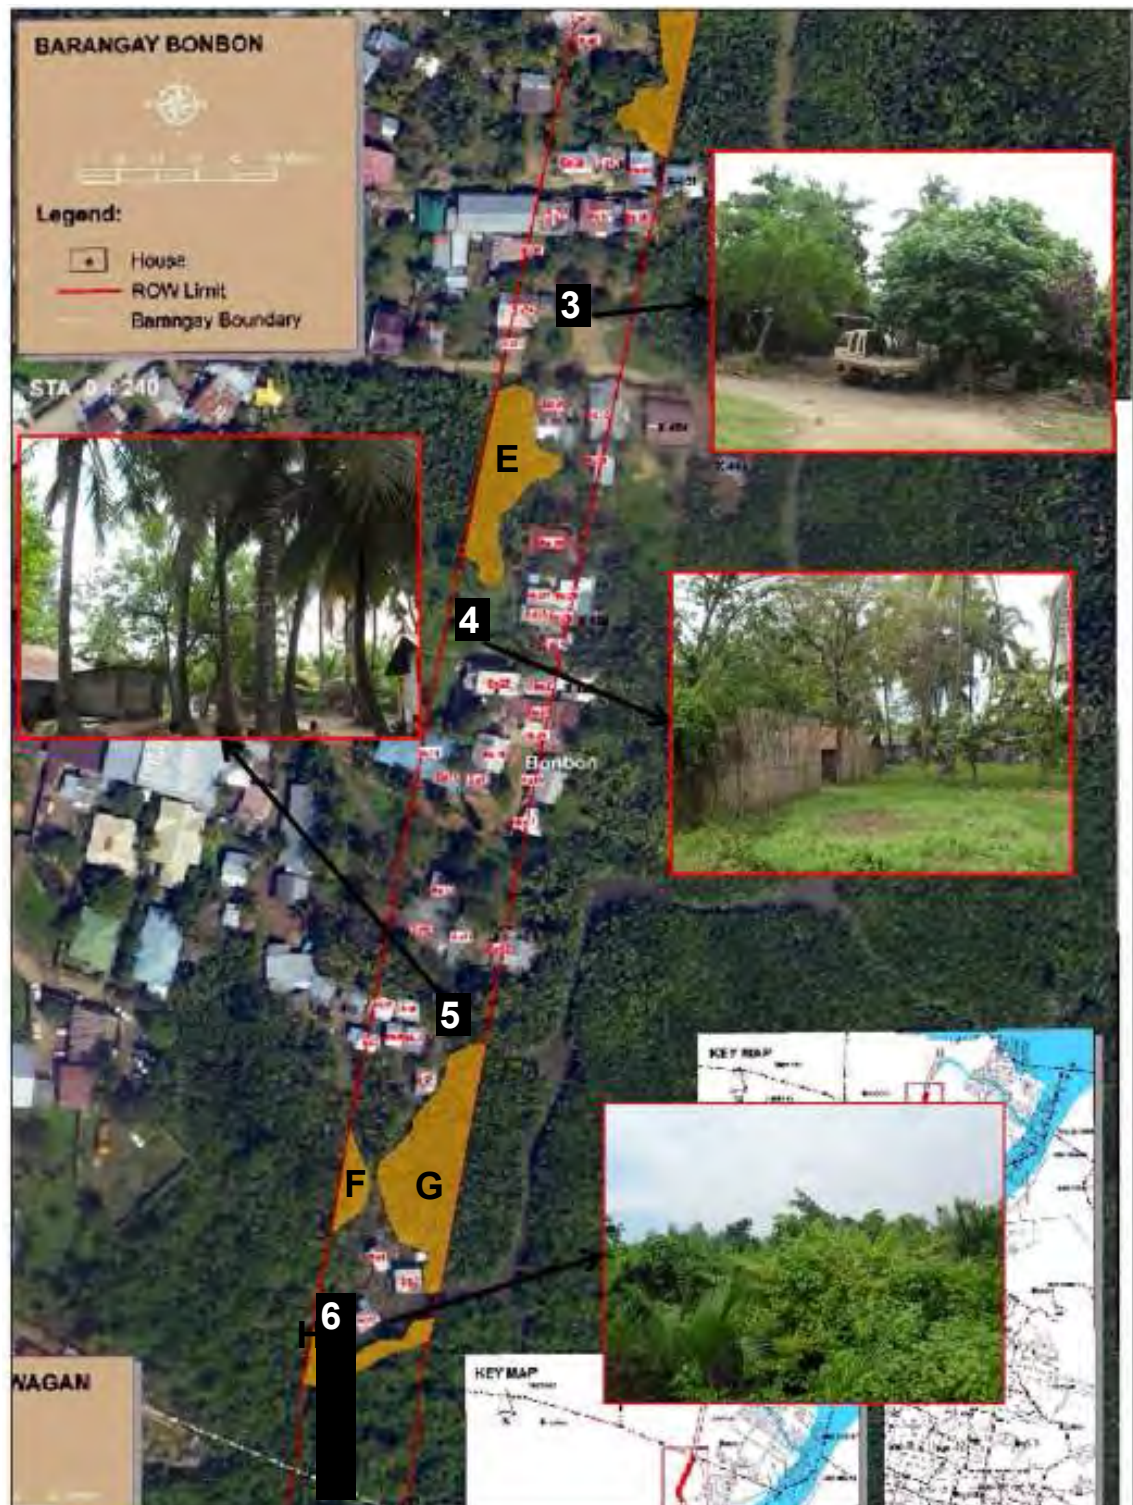
Figure 6.2.9 Mangrove forest to be affected by construction of project facility (evacuation road) near Barangay Bonbon (2 of 4 figures)

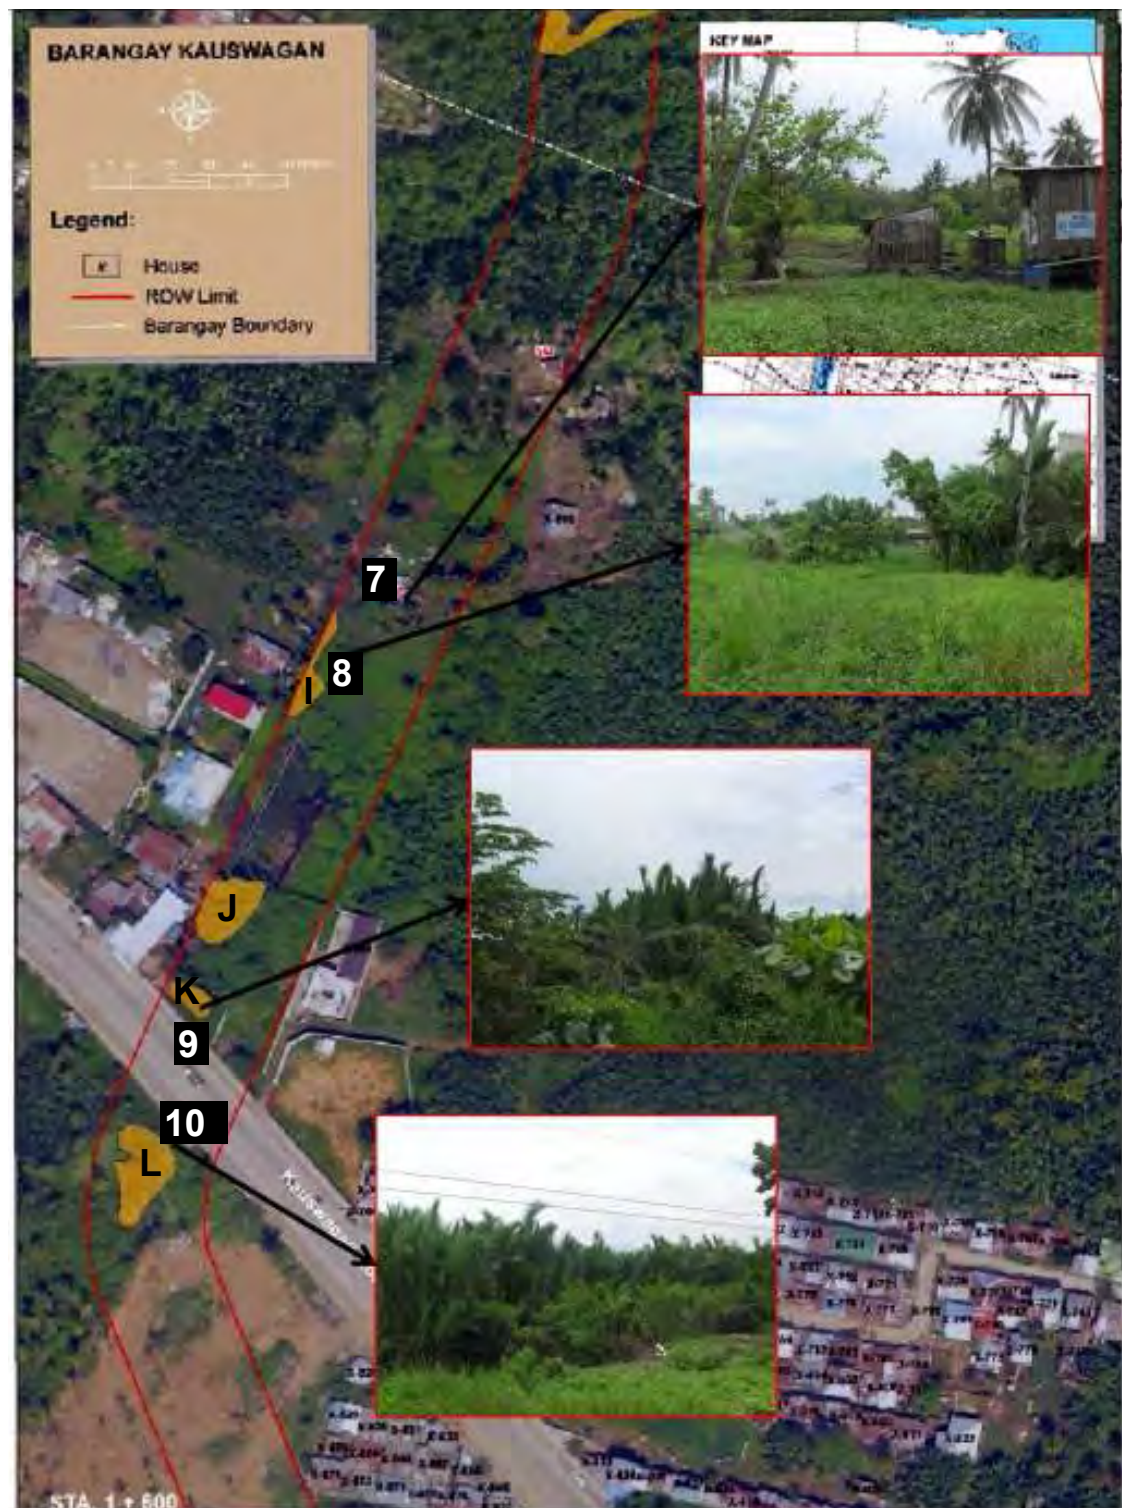
Figure 6.2.10 Mangrove forest to be affected by construction of project facility (evacuation road) near Barangay Kauswagan (3 of 4 figures)

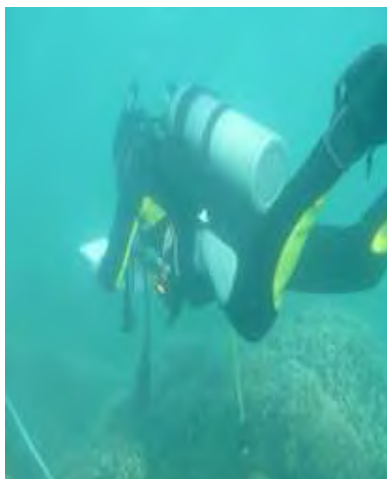
Figure 6.2.30 Picture showing LIT Survey

In coral reefs where significant live corals occur as compared to other stations surveyed in the manta tows, transect lines are laid out in order to more precisely estimate the relative abundance of living and nonliving things on the sea floor by diving (**Figure 6.2.30**).

The survey involved the laying out of 50-m transects parallel to the shoreline and following the reef contour in two stations identified in the manta tows. LIT was conducted at two locations. **Table 6.2.54** and **Figure 6.2.31** shows the survey locations. Data generated from the LIT method for coral reef assessment provides more rigid data sets on percent live coral cover as well as species distribution that can be ultimately used for comparative evaluation if the same survey stations are monitored in the future, under the Project's environmental monitoring plan.

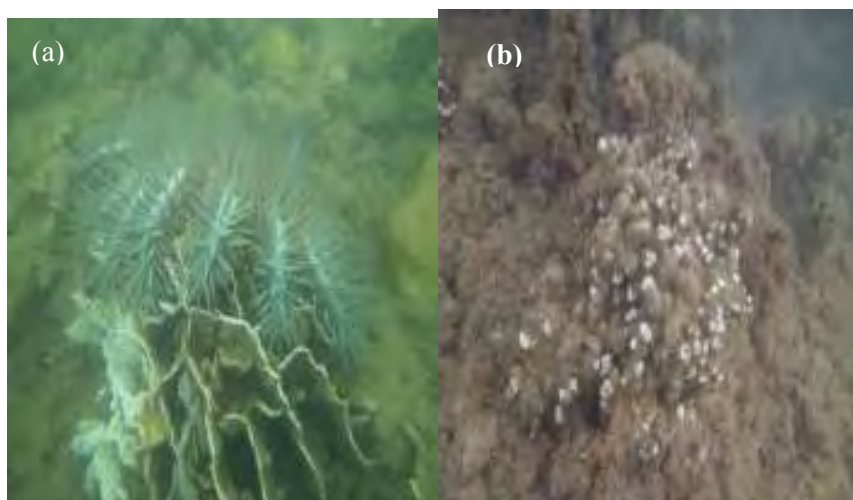
Figure 6.2.37 Prey of Coral and Condition of Coral Habitat (a) Crown-of-thorns starfish preying on a fire coral and (b) smothered branching *Acropora* sp. due to heavy sediment loading at the survey sites.
